PennDOT LTAP technical INFORMATION SHEET #220 SUMMER/2022

SIDEWALK MAINTENANCE ISSUES

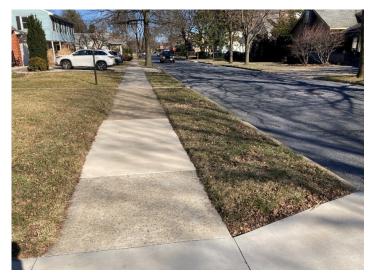
Figure 3: Per ADA and PennDOT standards, sidewalks shall be smooth, stable, and slip resistant. This shows a repaired section of sidewalk.

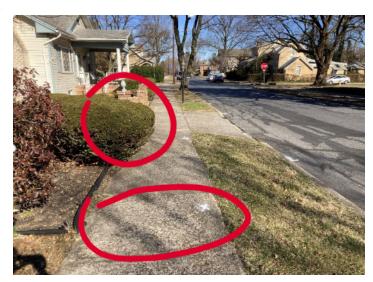
Figure 4: This photo shows vegetation limiting the width of the sidewalk, and a sidewalk panel that is not smooth and in need of repair or replacement.

- Vegetation blocking the pedestrian access route (PAR). The minimum width of the PAR is 4 feet, per ADA
- · Sidewalk panels that are deteriorating and are not smooth
- Gaps in the sidewalks/pedestrian transportation network
- Uplifted panels, gaps between panels, bumps, and edge drop-offs
- Locations without curb ramps
- Locations where the sidewalks do not continue across residential driveways
- · Signs and other posts that limit the PAR
- Drainage issues
- Short- or long-term work zones that block sidewalk access
- Snow and ice removal

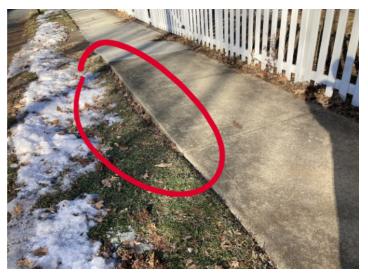
Figure 5: Edge drop-offs can be tripping hazards.

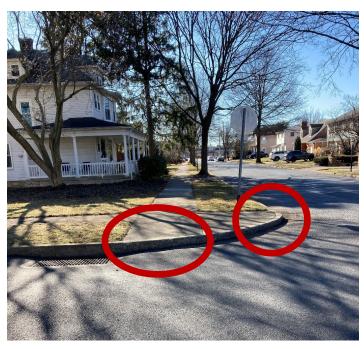
Figure 6: No curb ramps are present here.

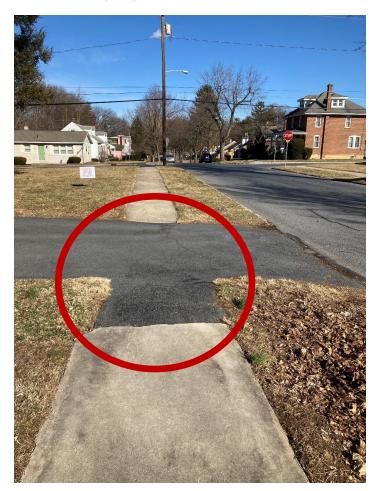
Figure 7: Sidewalks should continue across residential driveways.

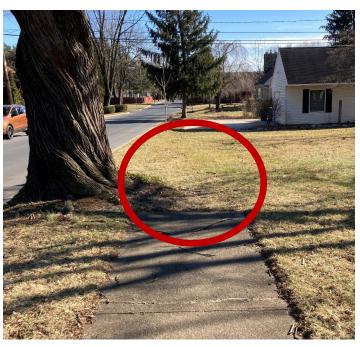
Figure 8: An example of a sidewalk gap in the pedestrian network is shown here. This could lead pedestrians into conflicts with traffic.

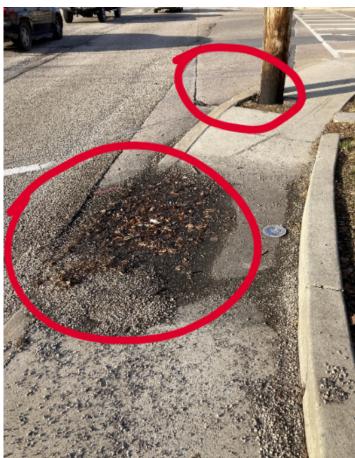
Figure 9: Ponding and other drainage issues can limit the functionality of a sidewalk and/or ramp. Also note the utility pole restricting the width of the sidewalk and PAR.

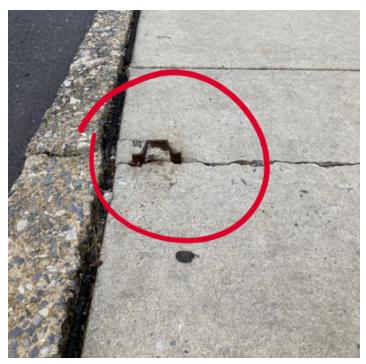
Figure 10: Old signposts and other objects can be tripping hazards and not compliant with the ADA. ADA identifies any protruding object over ¼ inch as a hazard.

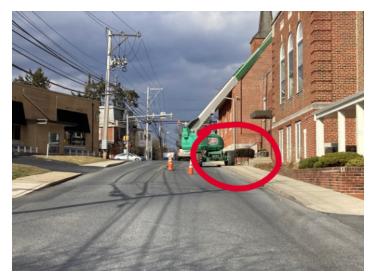
Figure 11: A work area that blocks a sidewalk, and forces pedestrians into conflict with traffic.

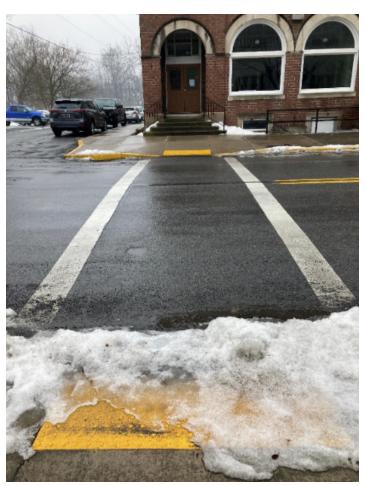
Figure 12: Water, snow, and ice can create barriers to access a sidewalk and/or ramp.
